**DYNAMIC SCIENCE, INC.**  
**In-Depth Accident Investigation**

**Contract Number DTNH22-94-D-27058**  
**Case Number DSI-94-AB-15**

## TECHNICAL SUMMARY

[REDACTED]  
This single vehicle crash occurred on a four-lane, divided, asphalt paved, rural road in [REDACTED] Maryland during the early morning hours of a summer weekday ([REDACTED] 94).

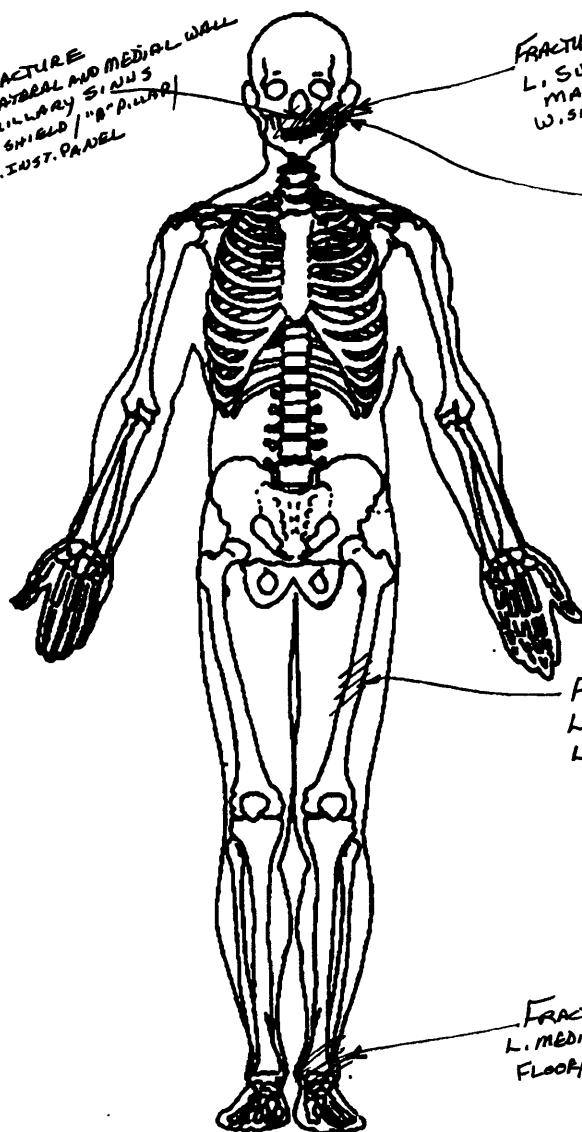
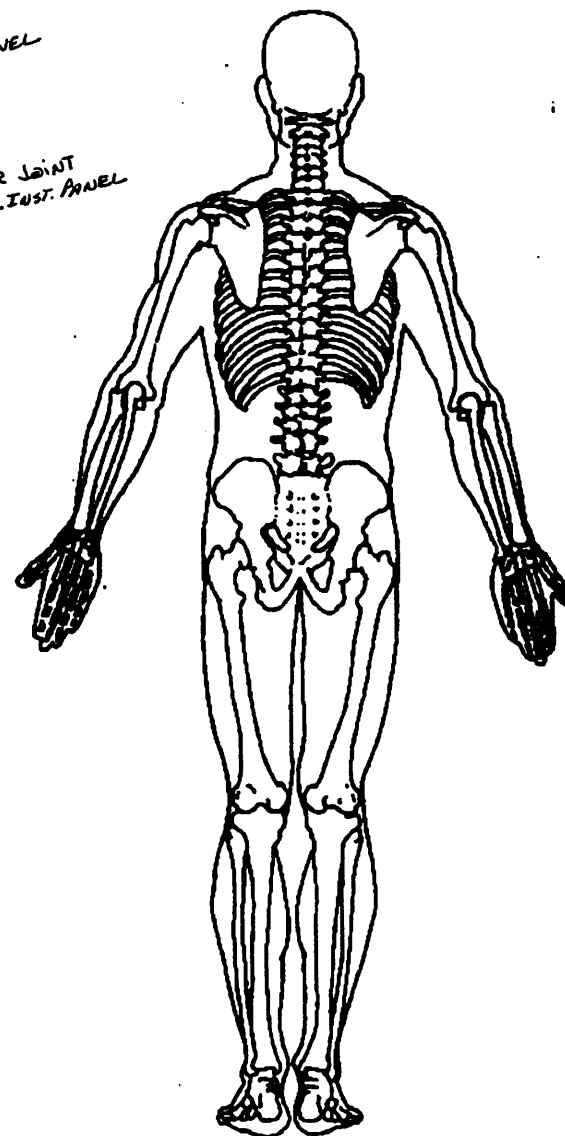
FRacture (OPEN)  
L. FEMUR SHAFT  
L. INST. PANEL

FRacture  
L. MEDIAL MALLEOLUS  
FLOOR / DE PAN

<b>INJURY</b>	<b>AIS/OIC CODE</b>	<b>ICD-9</b>	<b>SOURCE</b>
<b>DRIVER: (case occupant)</b>	Closed head injury with diffuse axonal injury (shear)	2140628.5,3141202	801.14	Windshield/"A" Pillar
	Contusion, cerebrum (bilateral) NFS	2140620.3,3141202	801.14	Windshield/"A" Pillar
	Fracture, L. Femur shaft (open)	2851814.3,2091203	821.11	L. Inst. panel
	Fracture, L. Subcondylar Mandible (open)	2250616.2,2141102	802.32	Windshield/"A" Pillar
	Dislocation, Temporomandibular joint	2251604.2,2141102	830.0	Windshield/"A" Pillar
	Fracture, L. Lateral and medial wall, maxillary sinus	2250802.2,2141102	802.4	Windshield/"A" Pillar
	Fracture L. medial malleolus	2853412.2,2561101	824.0	Floor/toe pan
	Laceration, chin 4 cm (into mouth)	2290602.1,8141102	873.44	Windshield/"A" Pillar
	Laceration, L. shoulder (clavicle area)	2790602.1,2411100	880.00	Shoulder restraint
	Laceration, R. shoulder	2790602.1,1979700	880.00	Unknown

Laceration, L. thigh	2890602.1,2091202	890.0	L. Inst. panel
	Contusion, L. elbow	2790402.1,2201100	923.11	Interior, L/F door
	Contusion, Chest (whole area)	2490402.1,0411100	922.1	Shoulder restraint
	Contusion, L. lower leg	2890402.1,2091102	924.4	L. Inst. panel
<b>R/F Occupant:</b>	Contusion, chest	7490402.1,4411100	922.1	Shoulder restraint
	Contusion, R. hip	7590402.1,1411100	924.01	Lap restraint
	Contusion, L. hip	7590402.1,2411100	924.01	Lap restraint
<b>R/R Occupant:</b>	Fracture, L. Wrist	7753202.2,2401100	813.43	R/F seat back
	Sprain, L. Ankle	7850206.1,2491100	845.00	R/F seat, cushion

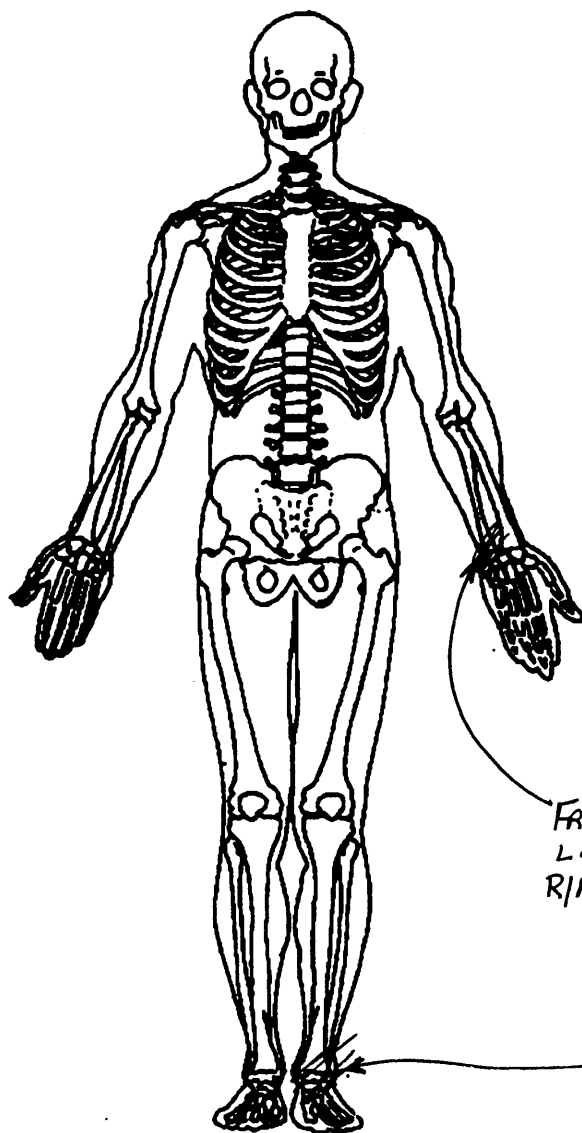
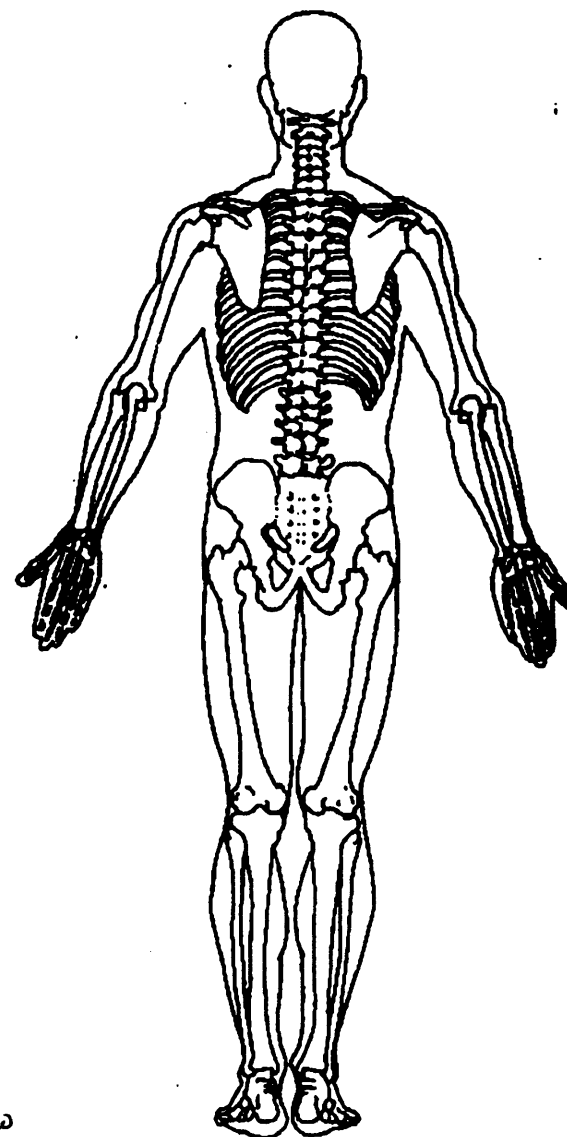
FRACTURE  
L. WRIST  
R/F SEAT, BACK REST

SPRAIN  
L. ANKLE  
R/F SEAT CUSHION.  
LOWER REAR PORTION

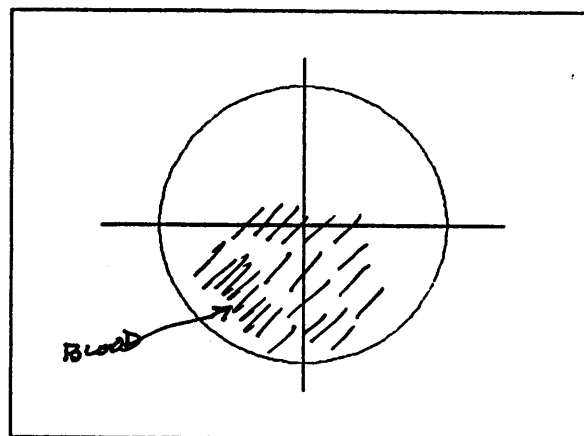
**FRONT**

**NOTE DAMAGE AND CONTACT MARKS ON AIRBAG DIAGRAMS  
 BELOW:**

The airbag was not damaged during the crash sequence and did not yield evidence of occupant contact. However, there were blood stains on the lower half of the bag that were most likely the result of post-crash bleeding by the driver.
